Manhole Inspection Summary

Manhole # S43C__011MH

Location Address: **922 Bethel St.**

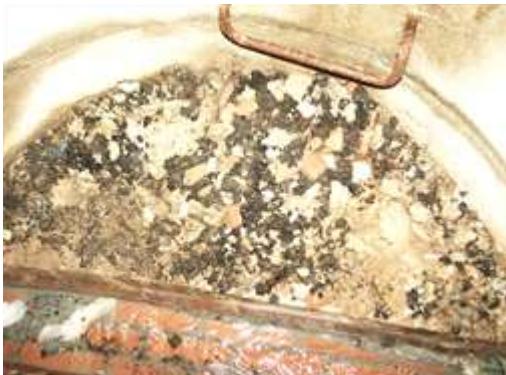
Defect 4

Condition: ☐ Sound ☐ Cracked ☐ Root Intrusion ☐ Deteriorated ☐ Leaks ☒ **Debris**

debris

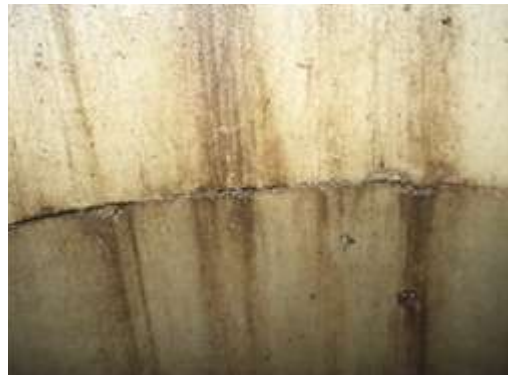
Defect 3

infiltration

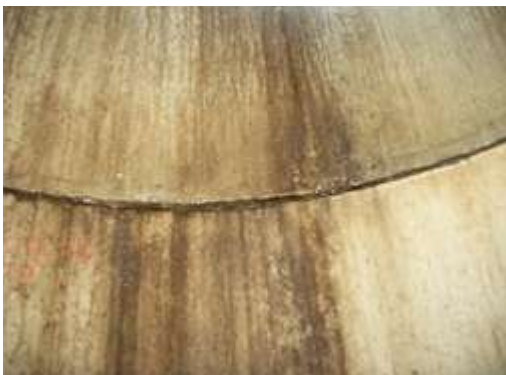
Defect 2

infiltration

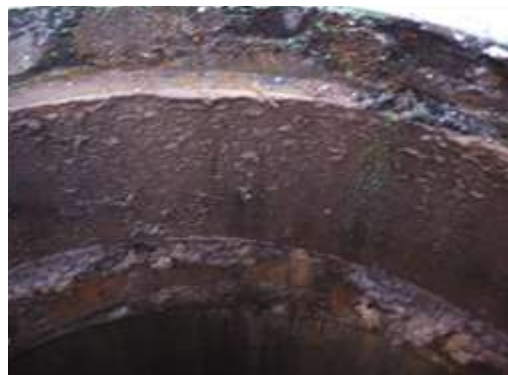
Defect 1

Frame Offset: **0** (in.) Condition: ☐ Sound ☐ Cracked ☒ **Leaks**

frame leaks

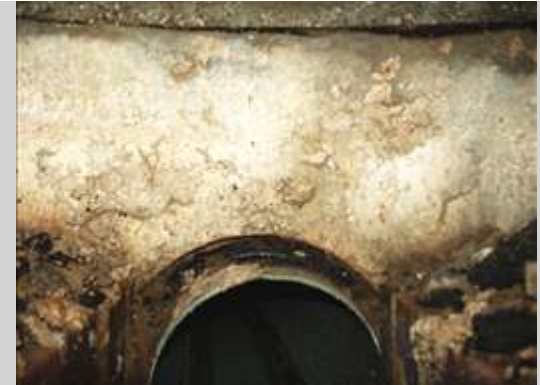
12 O'Clock Outflow

8 in. Circular Gravity Sewer
Pipe Out @ 12 O'Clock

Pipe Height: **8.4** (in.) Rod and Bar (Angled)
Pipe Material: **Clay** ☐ Pipe Lined
Invert Depth: **13.67** (ft.) Flow Characteristics: **Slow**
Deposits: ☒ None ☐ Mud ☐ Sludge ☐ Debris ☐ Grease
Silt Depth: (in.) Deposits Extent:
Infiltration: **None** Pipe Seal Cond: **Sound**

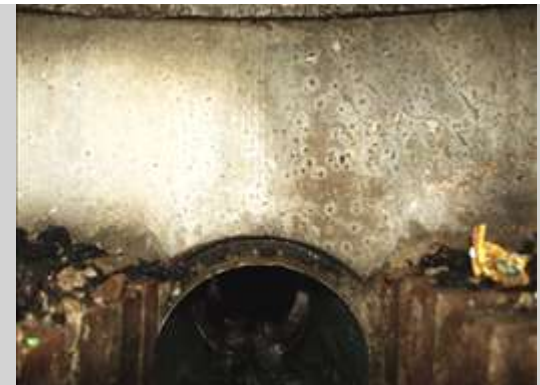
6 O'Clock Inflow

8 in. Circular Gravity Sewer
Pipe In @ 6 O'Clock

Pipe Height: **8.4** (in.) Rod and Bar (Angled)
Pipe Material: **Clay** ☐ Pipe Lined
Invert Depth: **13.75** (ft.) Flow Characteristics: **Slow**
Deposits: ☒ None ☐ Mud ☐ Sludge ☐ Debris ☐ Grease
Silt Depth: (in.) Deposits Extent:
Infiltration: **None** Pipe Seal Cond: **Sound**
